**MOLECULAR CHARACTERIZATION OF MICROBIAL
COMMUNITIES FOULING CONCRETE INFRASTRUCTURES**

In Partial Fulfillment
of the Requirements for the Degree
Master of Science in the
School of Biology

Georgia Institute of Technology
August 2008

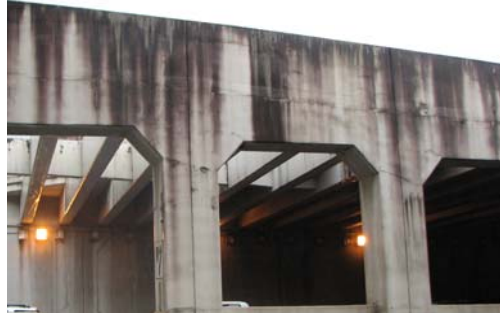
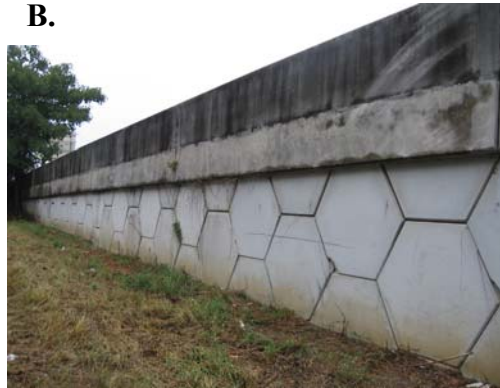
Figure 1.1. Examples of concrete biofouling. Fouling of a bridge parapet (A) and a concrete cap on a retaining wall (B) in Atlanta, Georgia.

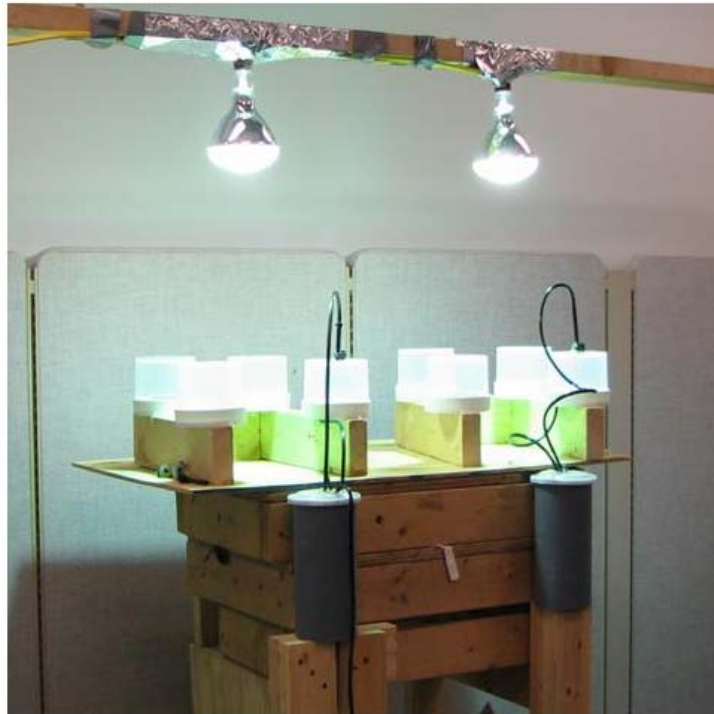
Figure 3.5. Biofouling incubations exposed to artificial sunlight. Tile surfaces received approximately 10 W/m^2 .

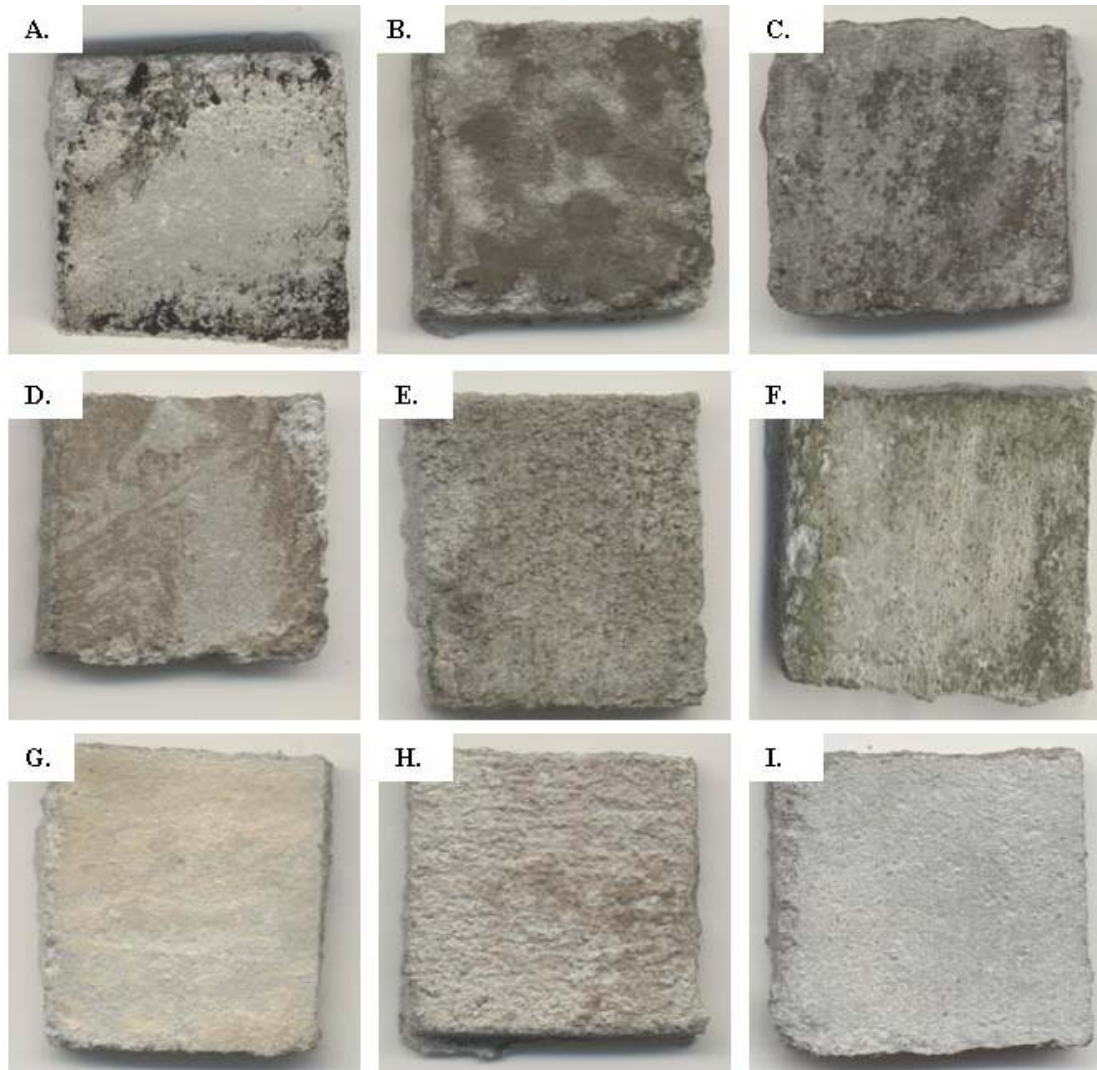
Figure 4.11. Biofouling of standard mortar tiles by individual cultured isolates; (A) *Epicoccum nigrum*; (B) *Cladosporium cladosporioides*; (C) *Fusarium* sp.; (D) *Mucor* sp.; (E) *Penicillium oxalicum*; (F) *Trichoderma asperellum*; (G) *Pestalotiopsis maculans*; (H) *Alternaria* sp.; (I) control incubation.
